Headbox process and condition test and Headbox Service

Headbox process and condition test

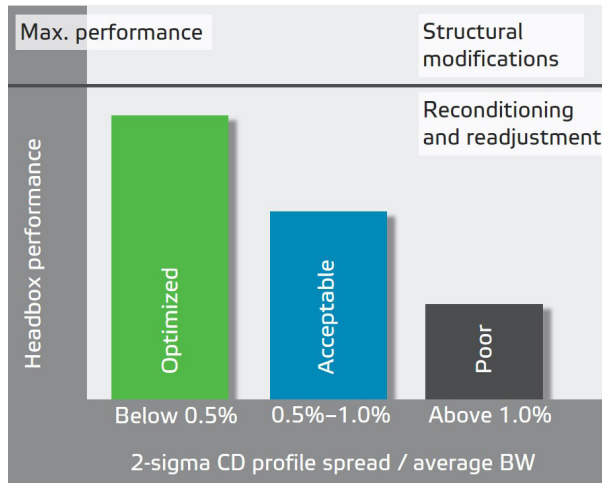
Figure 1. Headbox performance justified by CD profile spread

A quick evaluation of the headbox performance can be made by expressing the 2-sigma CD profile spread as a percentage out of the process average weight, e.g. 2-sigma of 0.6 g/m² divided by average basis weight of 80 g/m² gives 0.75%, which is acceptable.
